# Manhole Inspection Summary

Manhole # S51C\_\_061MH

Record Plat: **51C** Node: **061** Status: **New Manhole (Not in GIS)** Insp Date: **5/2/08 12:00 AM**

**Location** Address: **e. fairmount ave** Cross Street: **unknown alley**

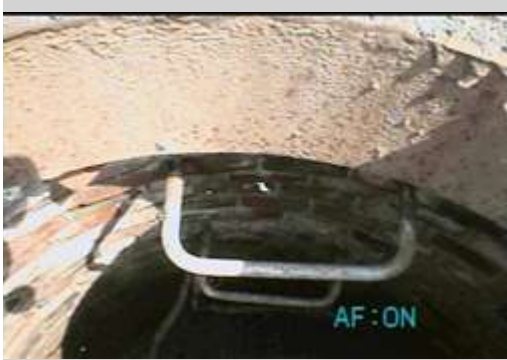
Misc.

view of steps

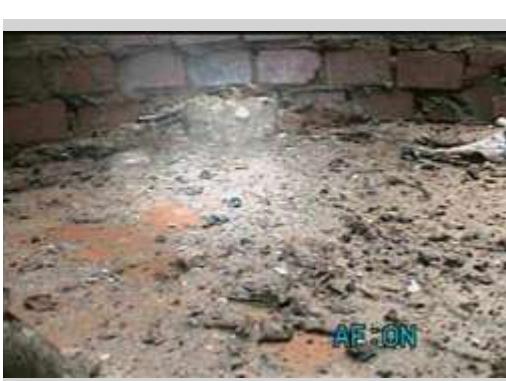
misc

bench debris

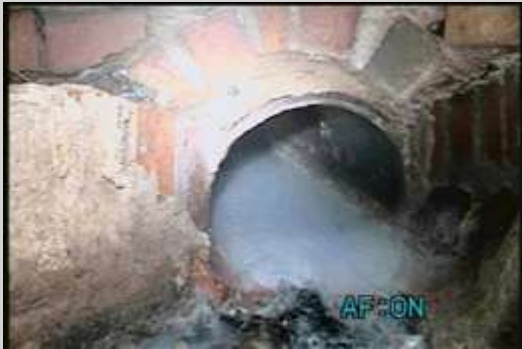
12 O'Clock Outflow

8 in. Circular Gravity Sewer  
Pipe Out @ 12 O'Clock

Pipe Material: **Clay** ☐ Pipe Lined

Invert Depth: **8.32** (ft.) Flow Characteristics: **Fast**

Deposits: ☒ None ☐ Mud ☐ Sludge ☐ Debris ☐ Grease

Infiltration: **None** Pipe Seal Cond: **Unknown**

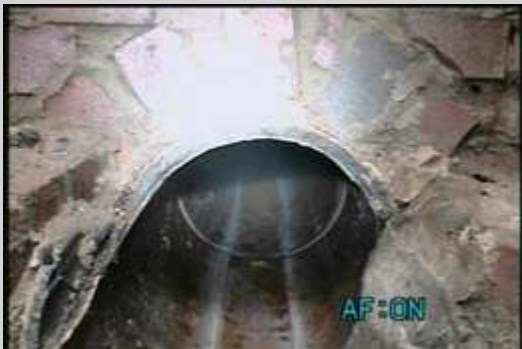
9 O'Clock Inflow

8 in. Circular Gravity Sewer  
Pipe In @ 9 O'Clock

Pipe Material: **Clay** ☐ Pipe Lined

Invert Depth: **8.26** (ft.) Flow Characteristics: **Fast**

Deposits: ☒ None ☐ Mud ☐ Sludge ☐ Debris ☐ Grease

Infiltration: **None** Pipe Seal Cond: **Unknown**
